HISTORIC STRUCTURE REPORT
on the
MOUNT ZION OLD SCHOOL BAPTIST CHURCH
Loudoun County, Virginia

Chapters I-VI
(90% Complete)

Prepared for
Loudoun County Virginia
Parks and Recreation Department

Monday 23 February 1998

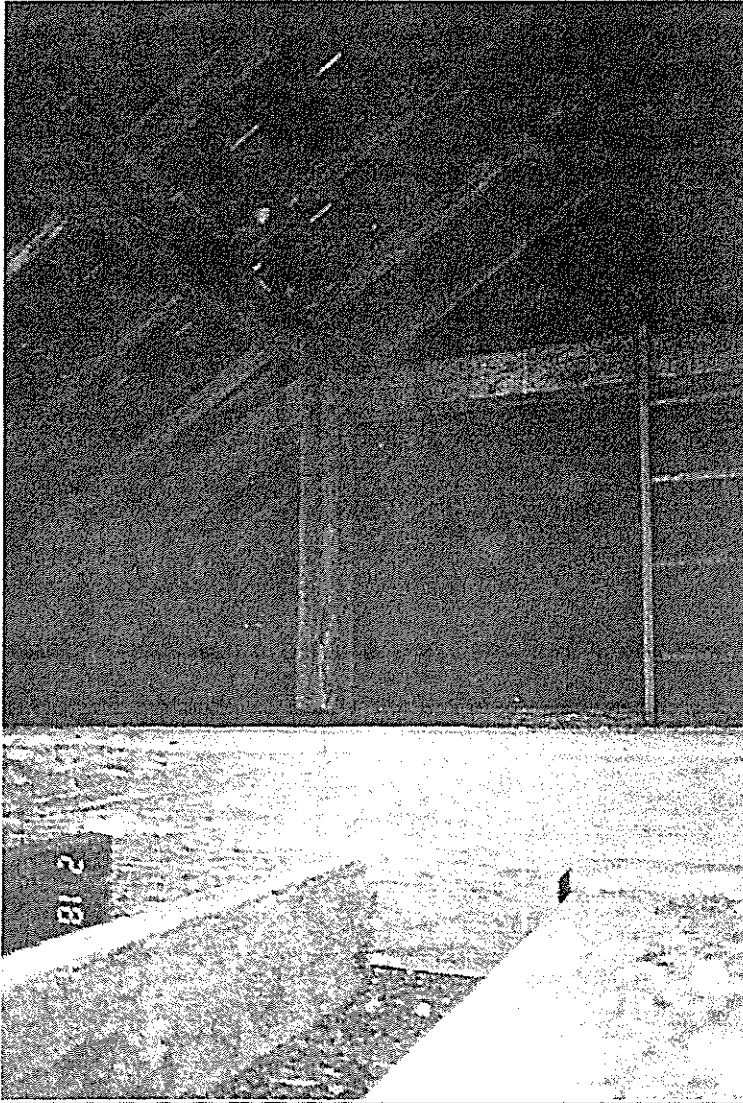
Figure 2: Roof Framing. The bottom chords of the trusses are 8x12" rough hewn pine timbers with joists of varied size running between them at 16" to 26" on center. Following the roof slope upward from each truss end are two 7-1/2"x8" chords, which meet the tops of 6'-0" posts approximately 10'-0" from the north and south walls respectively. (Photo taken: 11/97)

Roof framing has been affected by the relatively open condition of the attic. At the south edge of the building, the lower chords of the two easternmost hewn heavy timber trusses have been damaged by insect infestation. The south end of the westernmost truss has deflected downward. Wood at the connection between the lower chord of the second truss from the east and its south post has rotted. North truss ends show continued exposure to water, with the westernmost and third truss from west rotted and fibers crushed at heel joints. The north end of the second truss from west shows serious but lesser water damage. Roof joists support, 1x12" sheathing boards. Where the bats' claws grip the purlins' undersides to hang, the purlins wood fibers have been damaged by repeated scoring.

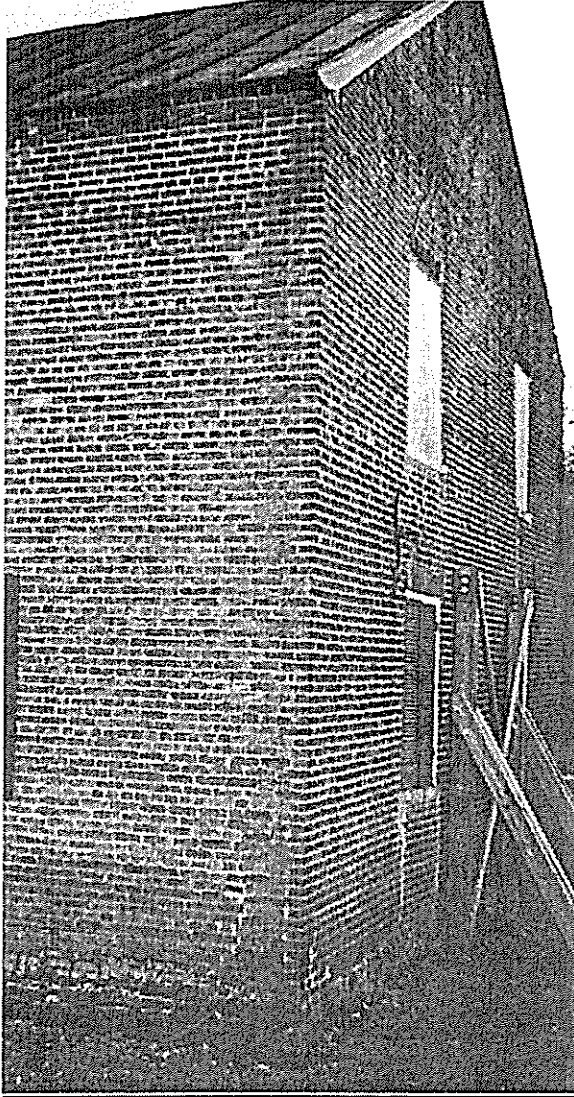
surface itself slopes downward toward the southwest (*Figures 9a, 9b*). At the north and west elevations, foundation mortar has crumbled due to water penetration and the wicking effect of the masonry. This problem has been aggravated by the lack of positive drainage condition at these areas, and dirt and mildew stains on the surface of the foundation show that the drainage problem is ongoing. At the northwest corner, portland cement grout has been applied in varying thicknesses to the stone foundation. A large stone at the base of the south end of the west elevation is dislodged from the wall and sits on the grass nearby. A brief assessment of the structure conducted in 1994 suggested that the two large white oak trees growing approximately 10'-0" from the east foundations may contribute to the destabilization of the church's foundations.

Figure 9 a: Masonry at Northwest. The foundation is comprised of locally-obtained basalt cobbles, and soft, sandy mortar which has eroded due to continued water exposure. Two large vertical cracks at the west ends of the north and south walls show that the foundation movement is affecting the brick masonry walls above. (Photo taken: 11/97)

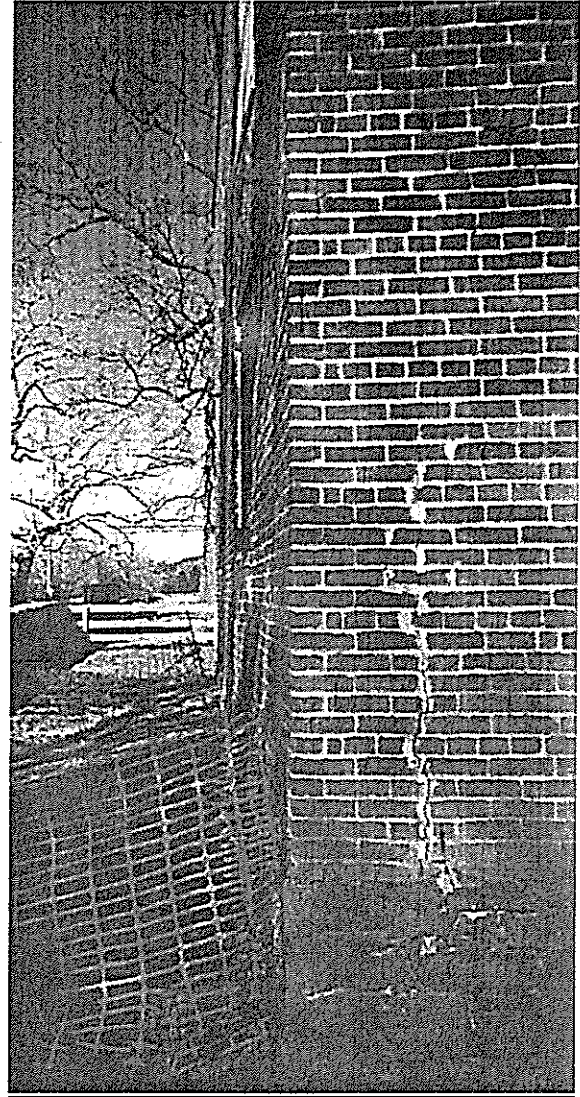
The stone foundation is made up of irregular field stones held by a porous, soft, sandy mortar. According to the 1997 geotechnical study conducted as part of this investigation, the stones are primarily locally obtained basalt cobbles, which are approximately 6 to 12 inches in size. The foundation's depth is roughly 2'-6" below grade as shown by the three test pits along the building perimeter. The foundation's height relative to grade varies from just below grade at the east elevation to approximately 1'-7 1/2" above grade at the building's southwest corner as the ground

Figure 9 b: Masonry at Southwest. The foundation is comprised of locally-obtained basalt cobbles, and soft, sandy mortar. The shrinking and expansion cycles of the clay upon which the foundation is laid have caused foundation movement. Two large vertical cracks at the west ends of the north and south walls show that the foundation movement is affecting the brick masonry walls above. (Photo taken: 4/97)

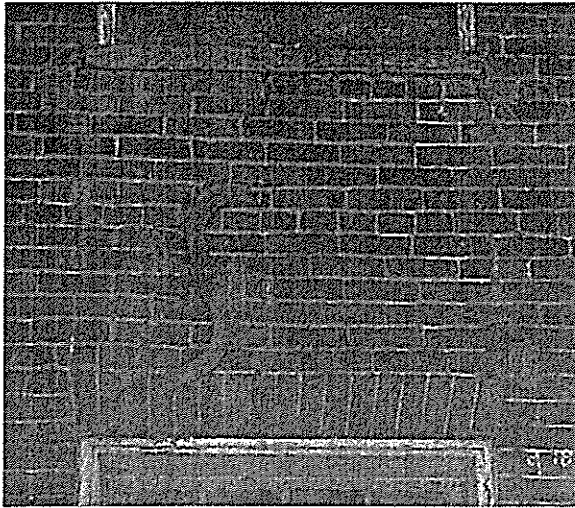
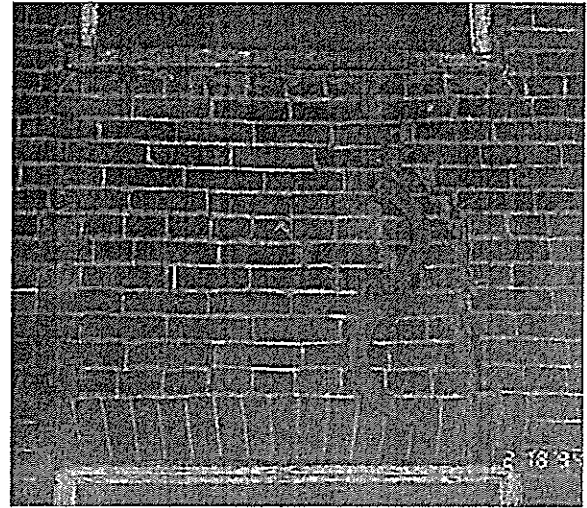
Although not as readily apparent as the west wall's deformation, east wall displacement is significant, as shown by the survey report. Fastened into the east wall at four inches above balcony level, two large (approximately 27" long) 'S'-shaped plates anchor portions of the wall into two 1-1/2" iron tie bars chains which span through the sanctuary to the west wall (*Figures 9a, 9b*). Running approximately 4" above the balcony floor, these pose an obvious tripping hazard. The installation date of these tie bars is unknown, but precedes 1984, when they were noted in a structural report by Brown Morton. Two smaller 'S'-plates are fastened into the wall just above first floor window jack arches, and appear to be anchored into the balcony framing, and were not noted in 1984. A 10" square anchor plate is anchored at approximately 14'-2" above grade, roughly 12" from the south edge of the elevation. This is connected to a steel cable which spans the length of the building above the balcony to a steel channel section anchor at the west wall. The tensile forces created by these anchor plates have caused cracking and deformation at each plate location. This failure is especially severe at the larger plates, and has caused major cracks in the jack arches above entry level openings here. Above the cornice line, east wall mortar has been severely eroded from the inside by water infiltration due to persistent roof leaks.

Figure 10a: Iron S-plate, East Wall. Two 27" long S-plates at approximately 4" above balcony level anchor portions of the wall to iron ties bars that span the length of the main hall to the heaving west wall. Masonry near these plates is in tension, and as a result, fractures and displacement is evident. The installation date of these plates is unknown, but precedes 1984, when they were noted in a report by Rev. Brown Morton. (Image taken: 11/97)

Figure 10b: Iron S-plate, East Wall. Two 27" long S-plates at approximately 4" above balcony level anchor portions of the wall to iron ties bars that span the length of the main hall to the heaving west wall. Masonry near these plates is in tension, and as a result, fractures and displacement is evident. The installation date of these plates is unknown, but precedes 1984, when they were noted in a report by Rev. Brown Morton. (Image taken: 11/97)

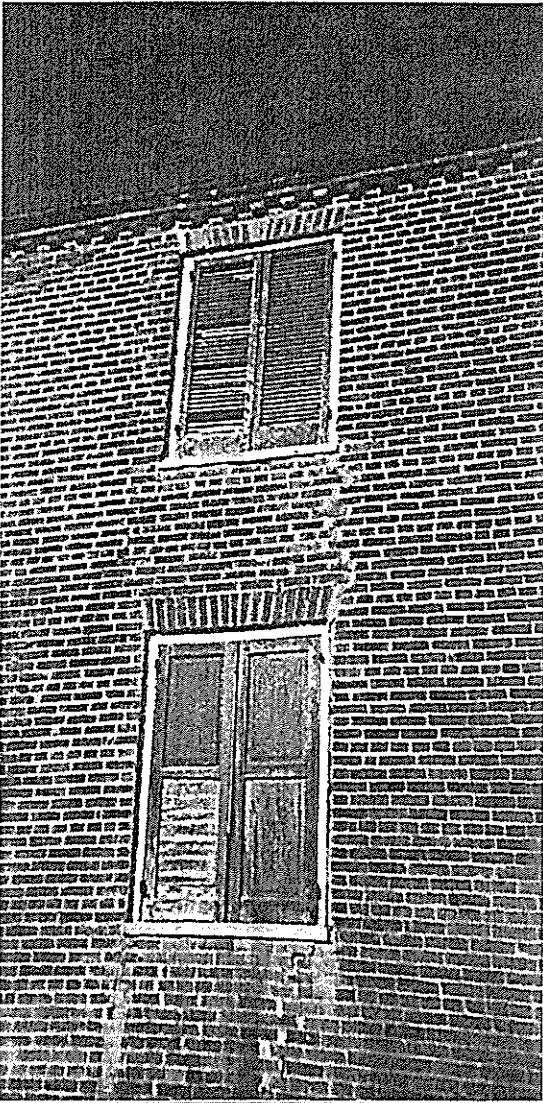
Window or door openings in the masonry walls are spanned by brick jack arches of 14 or 17 bricks respectively. Typically, large vertical cracks extend upward or downward from the corners of window and door openings, and jack arch conditions vary by location. In many locations on the north, west and south elevations, Portland cement mortar has been used to fill the cracks and may have caused further spalling of brick and mortar. At corresponding interior locations, diagonal cracks in finish plaster extend outward from heads and sills.

Figure 12: South Wall Vertical Cracks.
Vertical cracks in the south wall extend from grade up to the corniceline at every bay. Vertical displacement at the jack arches over windows is significant. (Image taken: 11/97)

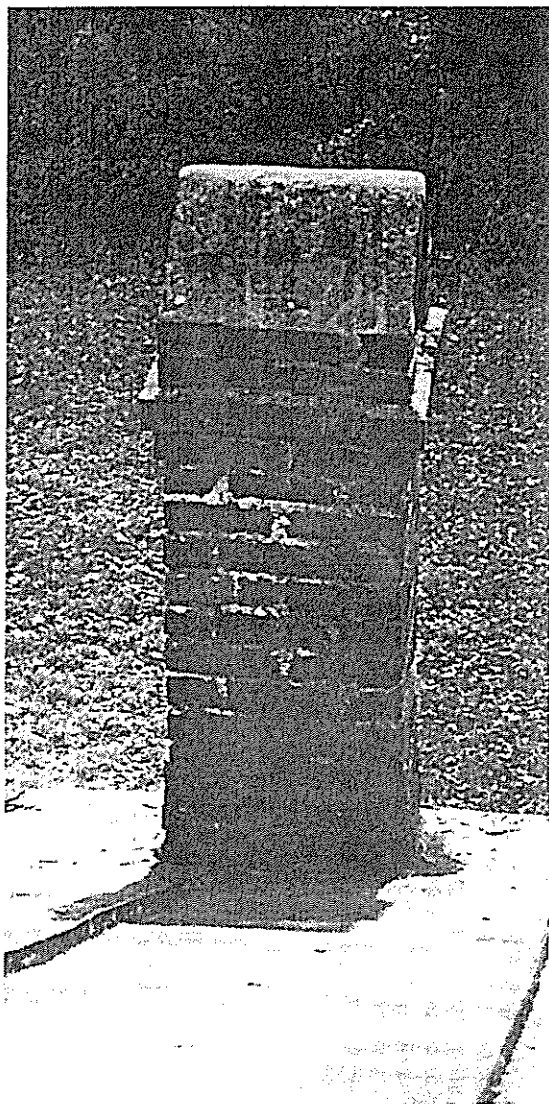
Figure 13: Chimney. The mortar at the chimney is eroded due to the corrosive effects of extreme temperature differences, water infiltration, and exhaust sulfates. (Image taken: 11/97)

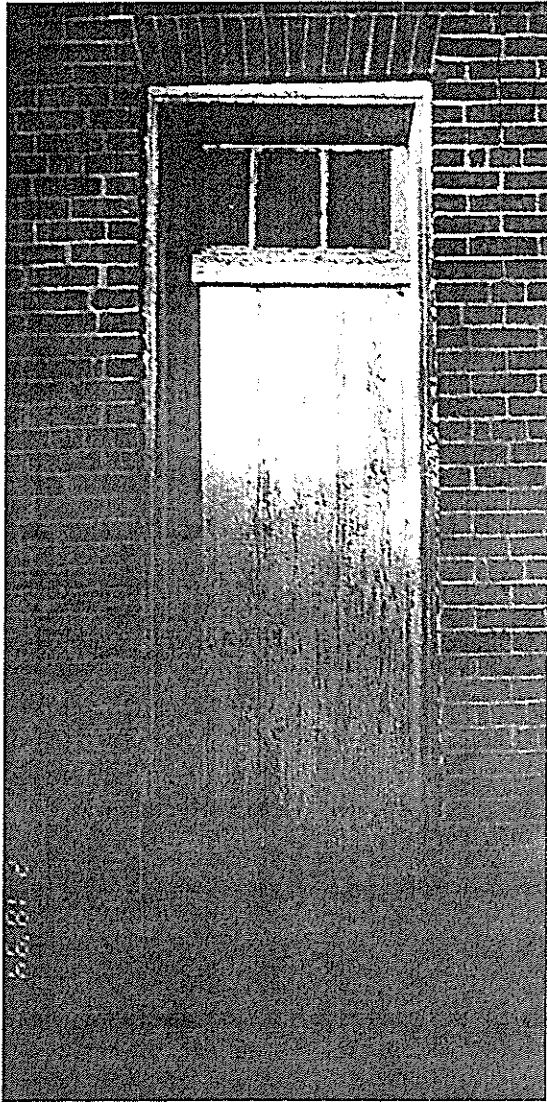
Figure 14: South Door. Made up of three vertical wood beaded boards, this door is fitted into the earlier frame with an extra shim board at the east jamb. This is likely the door for which the congregation petitioned the Federal Government for payment in 1905. Wood boards have been added to the lower jambs here in an effort to protect them from the elements. (Image taken: 11/97)

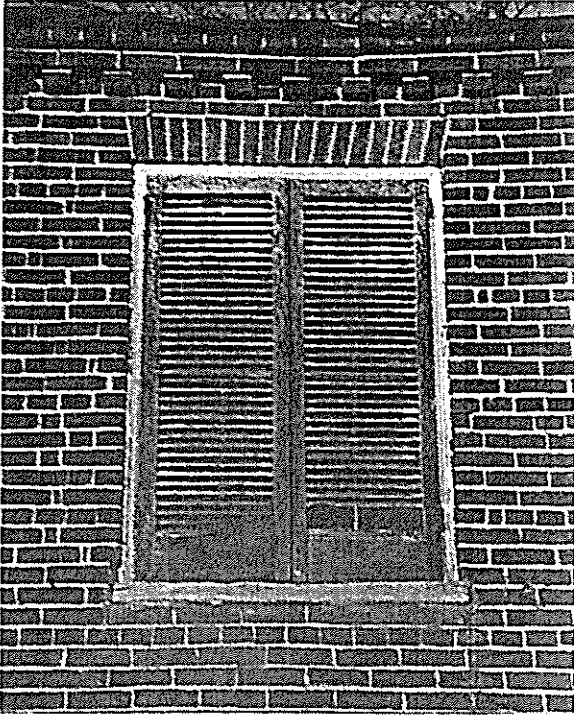
Typically, each of the balcony level windows is fitted with louvered shutters (*Figure 15b*). The louvered area of each shutter is 1' 4" wide by 5' 3-3/4" tall, with 1-3/8" louvers. Louvered shutter stiles are 2" wide, their lower rails 7-1/4" tall and upper rails 3" tall. They are located at all balcony level windows excepting those on the west elevation, which have been relocated to the lower west windows. Like the paneled shutters, the louvered shutters show traces of original paint with an original green finish. In many places all paint layers have worn completely off. At some locations, louvers are missing, and rail-stile joints are disengaged.

Figures 15 b: Balcony Level Shutters. Balcony level shutters are louvered. Paint analyses at the entry and balcony level shutters reveals only – layers of paint at shutters with the original finish composed of ... Original self-locking butt hinges are visible at many locations, with modern replacement hinges also common. (Image taken: 11/97)

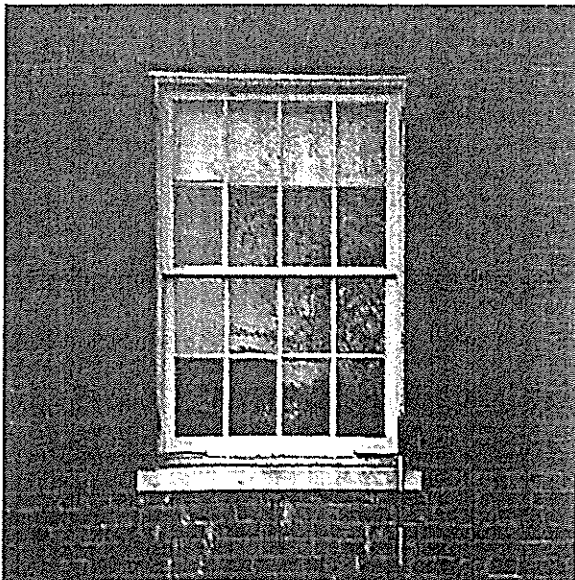
. Figures 15 a: Entry Level Shutters. Shutters at entry level are typically solid wood with raised panels. Paint analyses at the entry and balcony level shutters reveals only three to five layers of paint at shutters with the original finish composed of a forest green color. 'S' shaped iron hold open devices are anchored into the masonry at the corner of each shutter. (Image taken: 11/97)

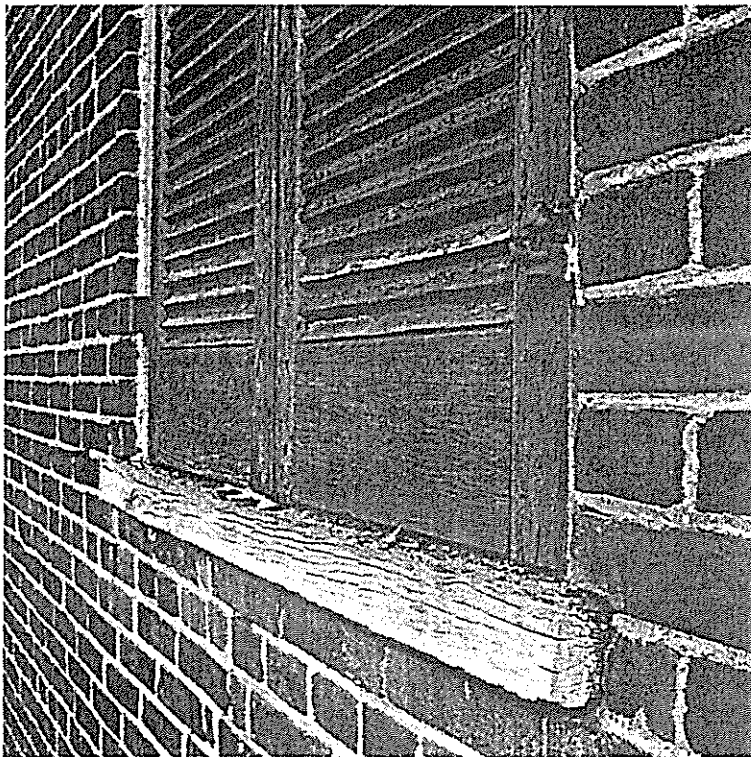
Each shutter includes two painted metal hinges (*Figure 16*). There are three types of shutter hinges currently present at Mount Zion; one type appears to date from the church's construction, and the other two are from later repairs as original hardware became damaged or corroded. The first type is a self-locking butt hinge as patented by Lull & Porter and shown in the 1865 Russell Erwin Hardware catalogue. These hinges are painted cast iron, and eight are remaining. They were not tested for operability. Replacement shutter hinges are painted cast iron butt hinges and appear to be relatively modern. They are in variable, but relatively good condition, although they were not tested for operability.

Figure 16: Shutter Hardware. The original hinges are self-locking butt hinges, patented by Lull & Porter and shown in the 1865 Russell Erwin Hardware Catalogue. Replacement hinges are simple cylindrical painted metal. (Image taken: 11/97)

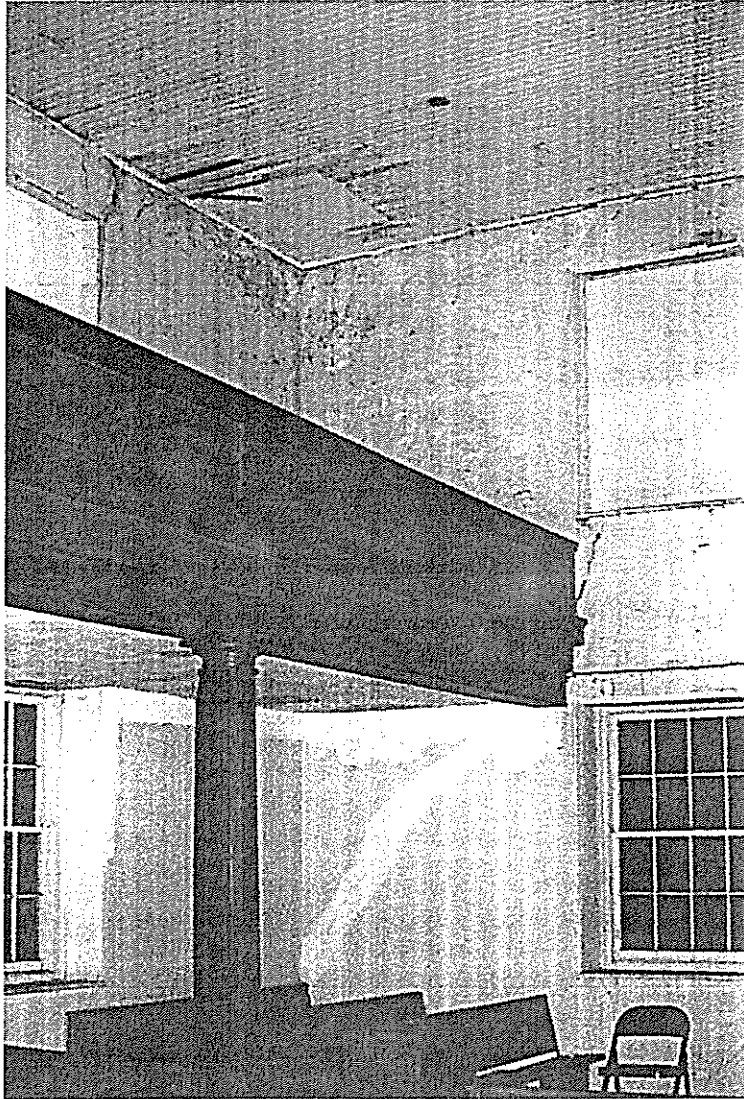
Figure 17: Southeast Corner Finishes. Ceiling boards are failing due to moisture and loading from attic debris. Wall finishes at the west ends of the hall show water damage and cracking due to the masonry problems discussed earlier. (Image taken: 11/97)

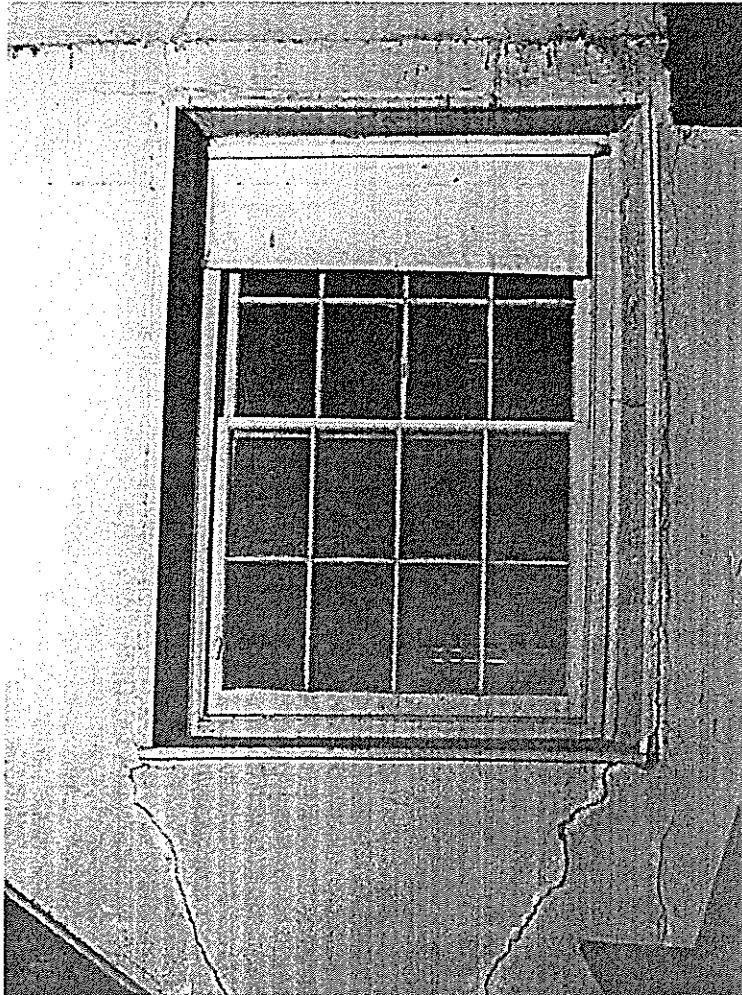
Figure 18: Interior Window View. Cracks in the masonry wall are affecting window casings and interior finishes. Deformation has caused the head casings to bow downward, while water infiltration has deteriorated plaster finishes. The windows themselves are in remarkably good condition, however. (Image taken: 11/97)
